DEPARTMENT OF TRANSPORTATION**DIVISION OF ENGINEERING SERVICES**

Contract #: 04-0120F4Cty: SF/ALA Rte: 80 PM: 13.2/13.9File #: 1.28**WELDING INSPECTION REPORT****Resident Engineer:** Casey, William**Address:** 333 Burma Road**City:** Oakland, CA 94607**Report No:** WIR-027830**Date Inspected:** 25-Jun-2012**Project Name:** SAS Superstructure**OSM Arrival Time:** 700**Prime Contractor:** American Bridge/Fluor Enterprises, a JV**OSM Departure Time:** 1930**Contractor:** American Bridge/Fluor Enterprises, a JV**Location:** jobsite**CWI Name:** William Sherwood**CWI Present:** Yes No**Inspected CWI report:** Yes No N/A**Rod Oven in Use:** Yes No N/A**Electrode to specification:** Yes No N/A**Weld Procedures Followed:** Yes No N/A**Qualified Welders:** Yes No N/A**Verified Joint Fit-up:** Yes No N/A**Approved Drawings:** Yes No N/A**Approved WPS:** Yes No N/A**Delayed / Cancelled:** Yes No N/A**Bridge No:** 34-0006**Component:** OBG**Summary of Items Observed:**

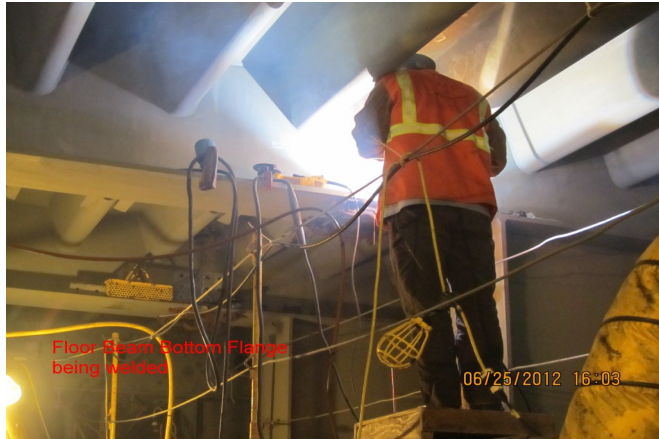
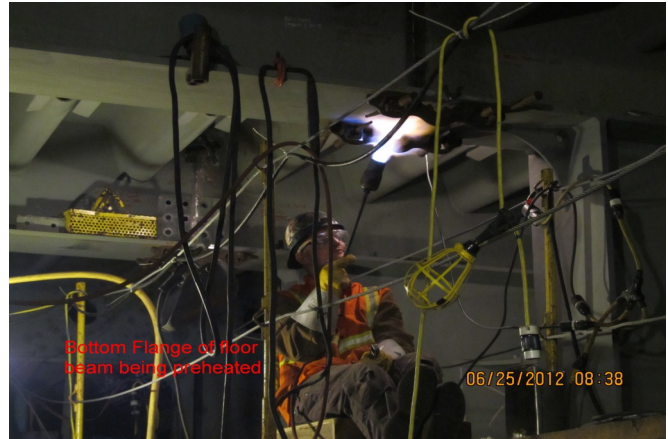
QAI witnessed the welding of stiffener plate PP120-TS1 by welder Tran Chau using the Shield Metal Arc Welding Process to the parameters of Welding Procedure Specification ABF-WPS-D15-1030. The welder was using the stringer technique and using a power wire brush to clean between passes. This QAI noted QC Inspector William Sherwood documenting welding parameters.
